Smoke and Dye Testing Summary

High Level Sewershed

Test ID	Test Type	Date Inspected	Company / Super.	Blower MH	Ground Condition	Notification Made?	Total Length
S1028-186	Smoke	7/21/2009	ADS/TM	S15AA_015MH	Dry	Yes	1,136.67

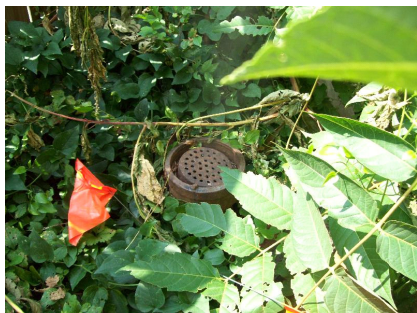
Picture \S1028-186-OB01-P01.jpg

Comments Smoke from above-grade cleanout (vented cap) in back yard. 2717 Lafayette Ave.

Comments Back yard, 2717 Lafayette Ave.

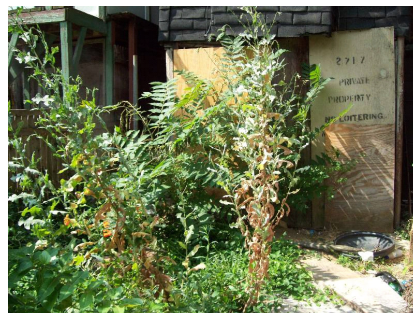
Picture \S1028-186-OB01-P02.jpg

Comments Smoke from above-grade cleanout (vented cap) in back yard. 2717 Lafayette Ave.

Comments Back of house (location view), 2717 Lafayette Ave.

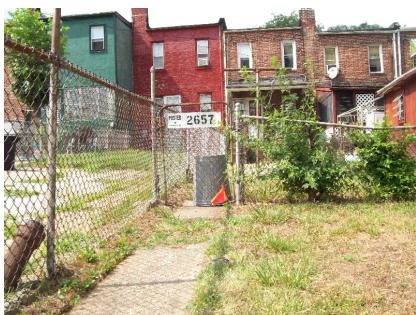
Picture \S1028-186-OB02-P01.jpg

Comments Smoke from above-grade cleanout (broken cap) in back yard. 2657 Lafayette Ave.

Comments Back of house (location view), 2657 Lafayette Ave.

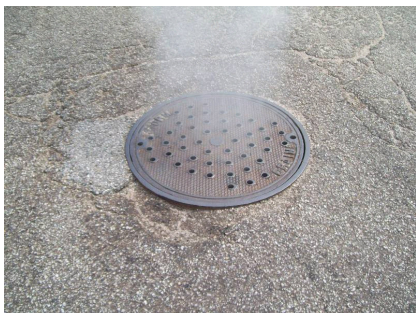
Picture \S1028-186-OB03-P01.jpg

Comments Smoke from sanitary manhole S15A_005MH with vented storm drain cover.

Comments Lanvale St. & Ashburton St.

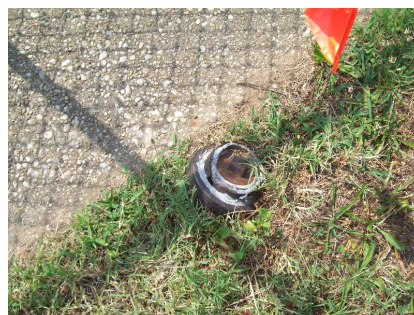
Picture \S1028-186-OB02-P02.jpg

Comments Smoke from above-grade cleanout (broken cap) in back yard. 2657 Lafayette Ave.

Comments Back yard, 2657 Lafayette Ave.

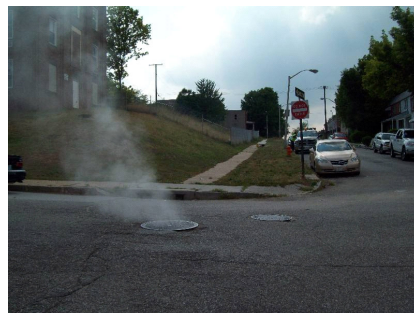
Picture \S1028-186-OB03-P02.jpg

Comments Smoke from sanitary manhole S15A_005MH with vented storm drain cover.

Comments Lanvale St. & Ashburton St. (location view) looking west
